Moisture Issues in Homes with Brick Veneer

issues with brick's ability to absorb water and how moisture can lead to condensation and mold

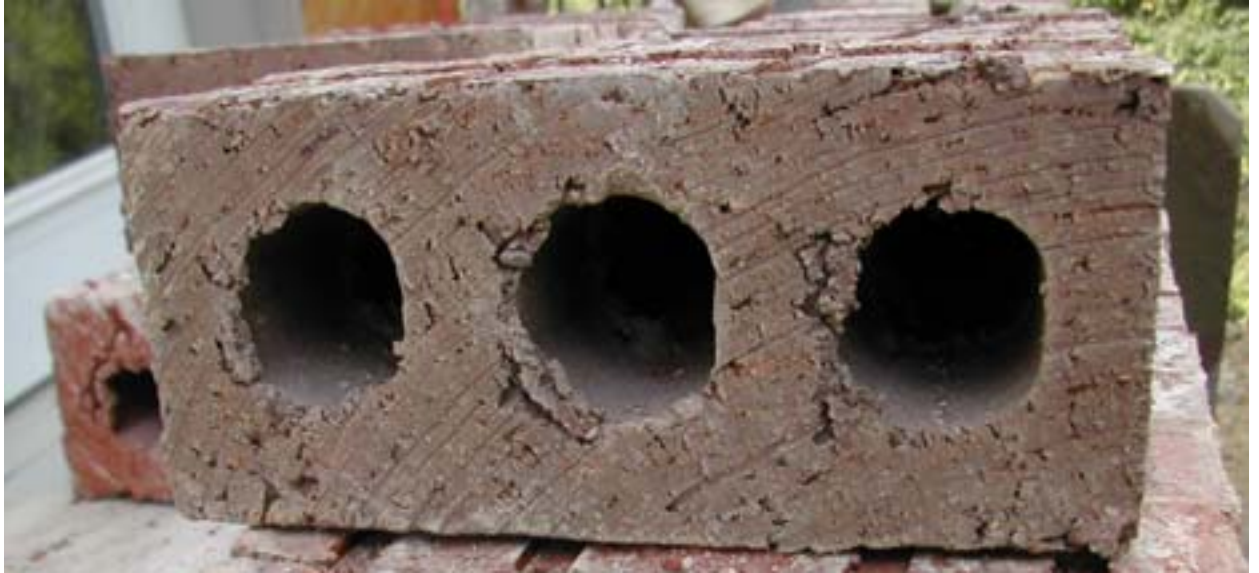
Brick veneer is a porous material. Both air and water can penetrate it, allowing moisture to move toward the wood framed walls of a home. The air space behind the brick allows moisture to be forced upwards due to stack effect, which allows this warm moist air to condense on cold surfaces like roof sheathing in an attic. Moisture on wood sheathing members can also lead to rot and possibly mold growth, both issues of safety, health, and durability in a home. Through our work with builders, IBACOS has seen various problems caused by a lack of air and moisture management techniques in homes that are clad with brick veneer. The three most common scenarios are:
